Investigating Hole-Wall to Hole-Wall Filament Growth Induced by PCB Design Features

Kevin Bivona; Bob Gosliak; Brian Sinclair; Caleb Ancharski
AGC Multi Material America
Tempe, Arizona, USA

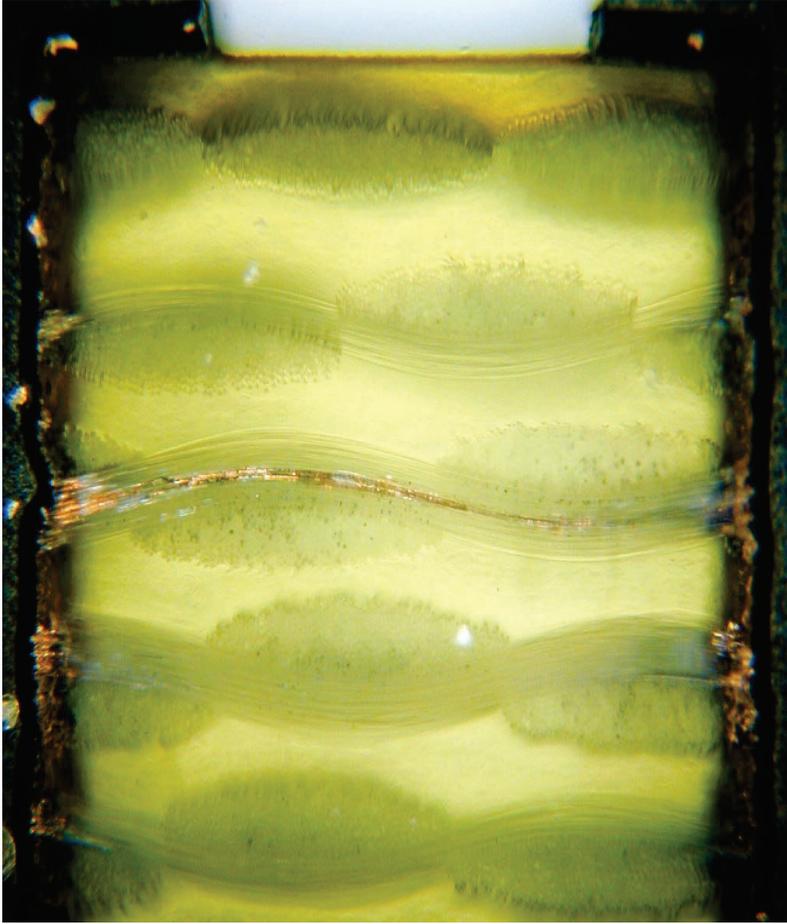
To illustrate what true CAF failure looks like, we have a “real world” example from an ultra-low loss resin system that was first treated onto fiberglass cloth to make prepreg, and then further processed to make laminates that were built into CAF test coupons. In Image 1 below, we can see that indeed, a conductive filament comprised of electrochemically formed copper salts has grown along the path of least resistance: the low-resin area in-between the glass fibers. Upon first review of these images, we of course hoped the failures were caused by the low-pressure areas that might have formed between the copper features that can be seen extending above the resin plane. Sadly, failure analysis confirmed that the failure did occur along the glass bundles, at the resin-glass interface; it was rather a classic Turbini-an case of CAF failure from degradation of the glass-resin bond.

Image 1: This image shows a cross-section of a CCL with CAF growing along a bundle of glass fibers. The glass fiber bundles can present a low-resin area that allows for Cu migration that leads to CAF failure.

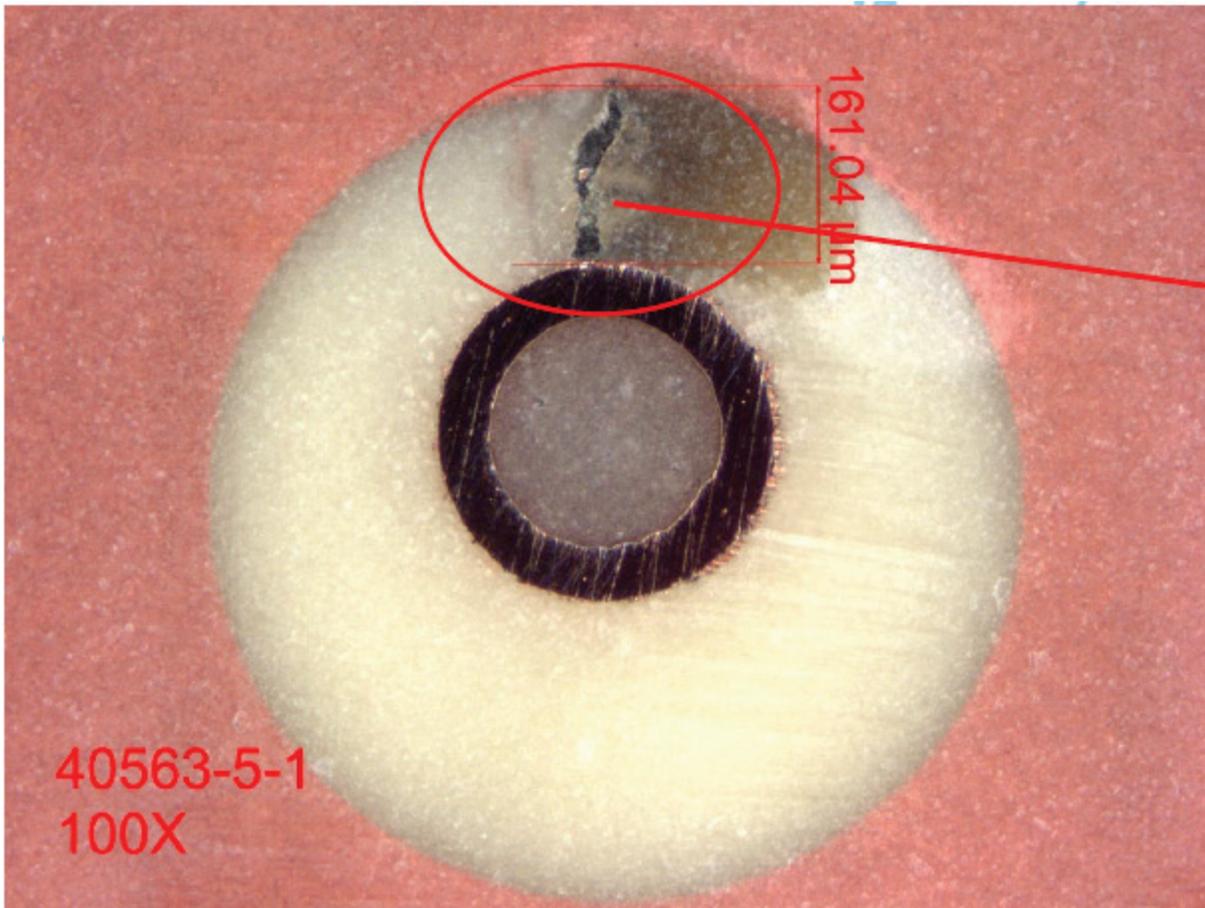
While working with an industry partner to qualify a new dielectric material, we encountered some CAF coupons that were failing during testing. After examining the coupons under a microscope (100-200x magnification), and carefully looking at all the available images, it became clear that the copper had migrated through a clearance ring between a via pad and an adjacent plane (Image 2). This clearance ring acted as a low-pressure area in a multi-layer stack (>12 layers) and likely subjected the layer above to mechanical stress. It was also noticed that the anti-pad was slightly off-center, which might be within tolerance, but as observed by Karavakis and Bertling [5] the spacing of features affects the likelihood of CAF formation to occur. So, it is not surprising to see that after meticulous sanding, polishing, & observation under 100-200x magnification revealed the filament formed adjacent to the degraded area where the copper-copper spacing was minimized. If the design had called for a higher resin content and/or perhaps used a task-targeted fill layer, then perhaps this failure might have been avoided.

Image 2: This image shows a slightly off-center clearance ring with degraded polymer and a copper filament that formed in the area where the Cu-to-Cu feature distance was at a minimum.

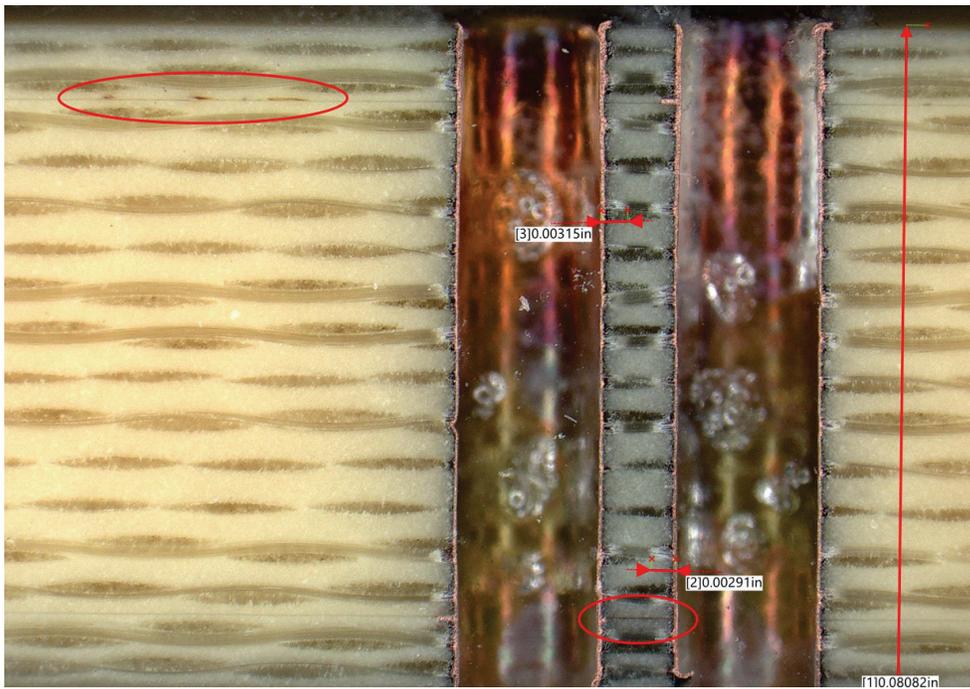
For our in-house CAF testing, we switched from 4-layer to 2-layer coupons to minimize the number of lamination bond-lines in the test vehicles. The often substandard construction quality of the coupons consistently lead to CAF formation along these bond lines (Image 3), thereby hampering the goal of testing the resin system's viability of withstanding CAF judged solely on the basis of its chemical makeup. Poor bond-line quality in the sample gives a pathway for moisture adsorption, which in turn leads to copper ion migration. Despite attempting a few rounds of troubleshooting with our coupon fabricator, the easiest way to exclude the unwanted influence of the sample fabrication process was to simply eliminate the extra bond lines by using a 2-layer construction.

Image 3: The image shows a cross-section of a 4-layer CAF coupon; the lamination bond line has allowed CAF formation (circled in red near the top left) between the first and second layers in the stack.

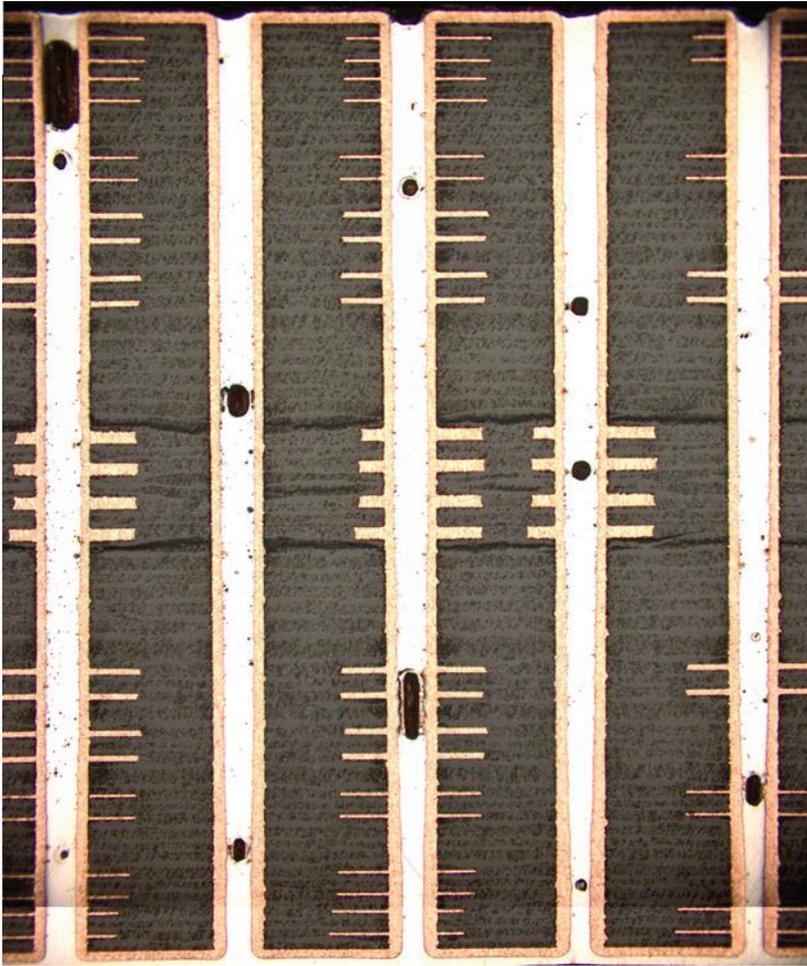
Another interesting case of suspected material-caused CAF failure happened when inter-connect defects were found within a set of test vehicles. While examining cross-sections, we found delamination from the copper in the middle of the stack due to low resin content (Image 4). In the image below, the dark areas are voids that occurred due to the design calling for low-resin content materials. Although there is often a need to hit certain thickness targets, minimizing resin content makes any design vulnerable to the defect(s) presented below. It is interesting to note there were multiple hole diameters in the design (0.2, 0.25, & 0.30 mm) but only the smallest hole diameter saw defects. After heat shock, multiple low-resin areas showed cracking at the heavy copper non-hole drill areas, and as observed elsewhere, the low-resin areas presented low-pressure areas which coincided with CAF formation.

Image 4: This image shows a cross-section of a test vehicle where voids have appeared due to low resin content in the middle of the stack; the voids are the dark areas. These voids served as low-pressure areas that led to inter-connect defects during lamination.

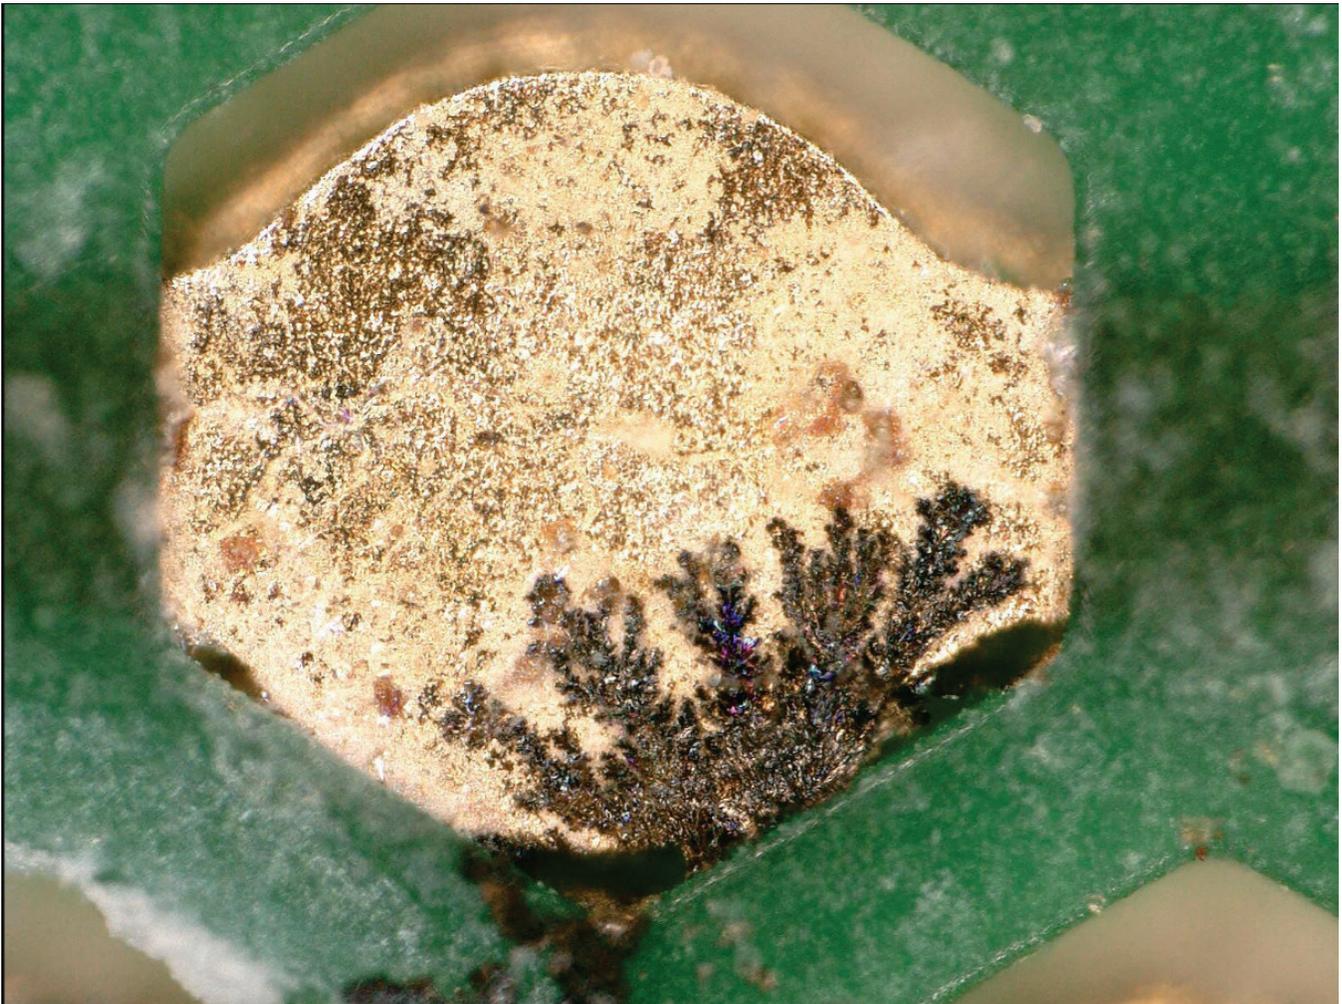
In the next example, we see the classic dendritic growth pattern exhibited by the migration of copper ions forming a filament (Image 5). However, these filaments are not seen growing between the glass-resin bond inside the body of the test vehicle, but rather they are migrating across an over-coated surface that was treated with a solder mask product. The OEM who tested these coupons examined them internally and did not report CAF growth through the glass-resin system. It seems the choice of solder-mask product may have been incompatible with the high-humidity, high-voltage test environment presented by the CAF test procedure.

Image 5: This image shows dendritic growth forming on the surface of a test vehicle. Despite having the appearance of a classic CAF failure, since the filament does not form at the resin-glass interface, this is not considered a failure of the substrate resin system.

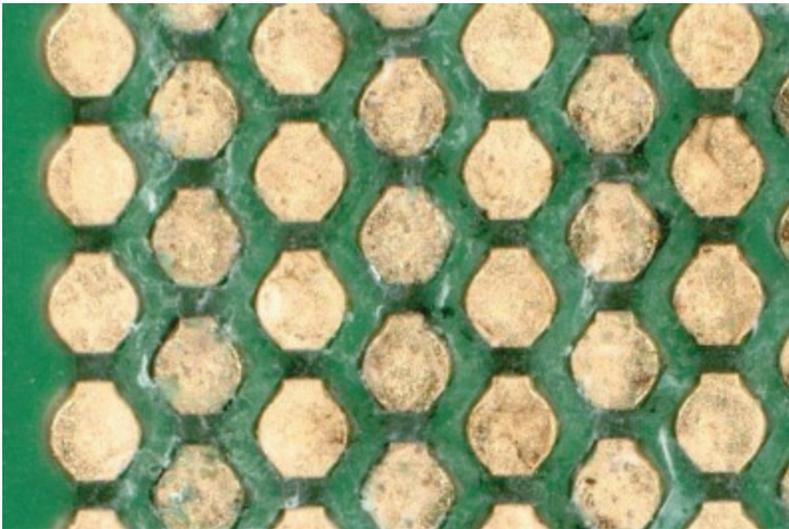
Below is another example of surface defects leading to failure during CAF testing that was not a true material-caused CAF formation (Image 6). The image shows surface contamination that is consistent with poor rinsing after the application of solder mask. This example illustrates the importance of meticulous construction and cleaning procedures.

Image 6: This image shows residue on a test vehicle that was left behind after insufficient rinsing following the application of solder mask. This residue can lead to a drop in resistance during CAF testing that mimics a true CAF failure.

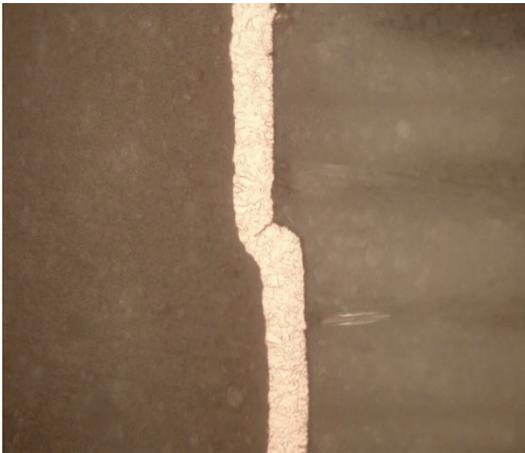
One final example of a failure during CAF testing that was not a true CAF failure is shown below. In this example, a flip-drill procedure was not properly performed (Image 7). The initial hole was drilled, the test vehicle was flipped over, but proper alignment was not maintained. This led to the second hole being out of alignment with the first, causing a cascade of problems for the rest of the construction process. Even in a six-sigma process, defects like these are bound to occur, but this example serves as an illustration of the importance of following up on all “CAF failures” with proper failure analysis. Whether analyzed manually by cross-section & microscope, or non-invasively by X-ray or other imaging techniques, good failure analysis is paramount to revealing what really went wrong.

Image 7: This misaligned copper feature (hole wall) was caused by an error during a flip-drill procedure.
